## Space Shuttle Overhead Windows, Optical Tests, Final Report

K. P. SCOTT  
Optical Systems Department  
Electronics and Sensors Division  
Engineering Group

June 1991

THE AEROSPACE CORPORATION  
El Segundo, California

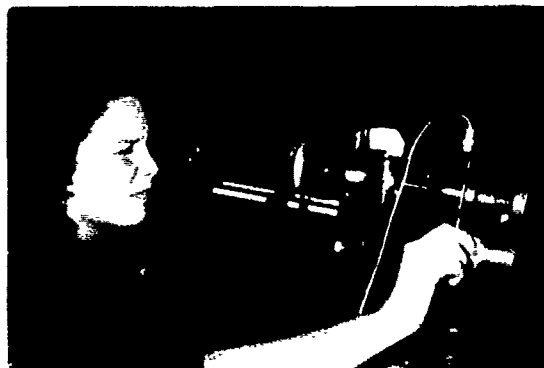
Figure B-5. Photographic Assembly

The photographic assembly probably was the most complicated (Photographs 5 and 6, Appendix B). As will be explained in Section 6, focusing the telescope to the camera was very difficult. It was found that a microscope was needed so that the telescope could be focused directly onto the film plane. The Nikon viewer assembly, even when a ground glass focusing screen was used, was found to be too inaccurate to use for focusing the telescope image onto the film plane. The main problem was the slightly inaccurate placement of the 45° fold mirror which directs the image to the focusing screen or view finder at the top of the camera (we found this problem in all the cameras tested).

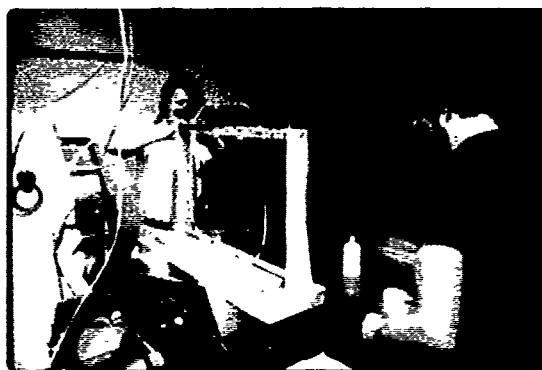
Figure B-11. Zygo with Window Frame

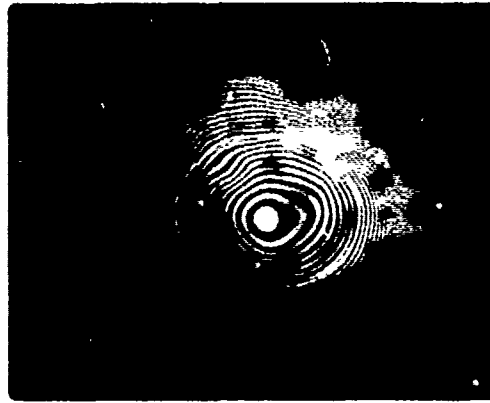
Figure G-1. Center (three panes)
